# EXPERIMENTAL APPROACH OF COCONUT PEELING PROCESS

**Henri Bailleres<sup>1</sup>, Louis Denaud<sup>2</sup>, Jean Claude Butaud<sup>2</sup>, Robert L. McGavin<sup>1</sup>**

## ABSTRACT

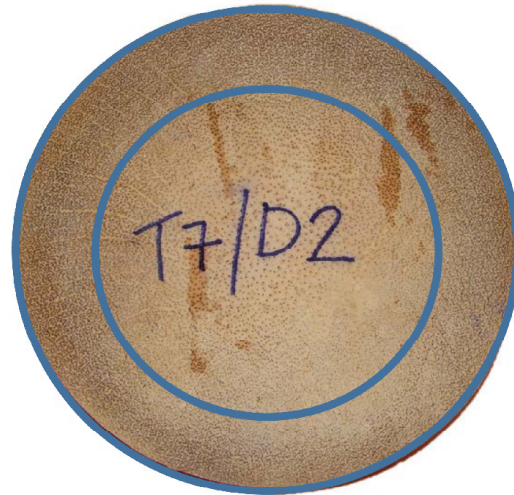
**Figure 1:** Coconut disc showing that the most valuable area for high density veneer production lies between the blue circles

The fibrovascular bundle architecture follows an interlocked helix formation as it ascends the trunk. The specific architecture of cocowood has been described as a triple helix structure (2, 3, 4). Unlike the dicotyledonous trees traditionally used by the forest products industry, coconut palm (*Cocos nucifera* L.) is a monocotyledon. Due to the huge variation in cocowood's density, production of high-quality veneers from the external part of coconut palm logs appears to be the most attractive way to use this resource (Figure 1). However, the unique structure of cocowood requires tight control of peeling parameters.
